**UNITED STATES AIR FORCE**  
**GROUND ACCIDENT INVESTIGATION**  
**BOARD REPORT**

**SEARCH AND RESCUE TACTICAL VEHICLE –  
SIDE BY VEHICLE  
S/N SRTVSXVD21AFM060**

**TYPE OF ACCIDENT:  
Tactical Vehicle Serious Injury**

**DATE OF ACCIDENT: 17 February 2023**  
**BOARD PRESIDENT: Colonel Brendan M. Noone**  
**Conducted IAW Air Force Instruction 51-307**

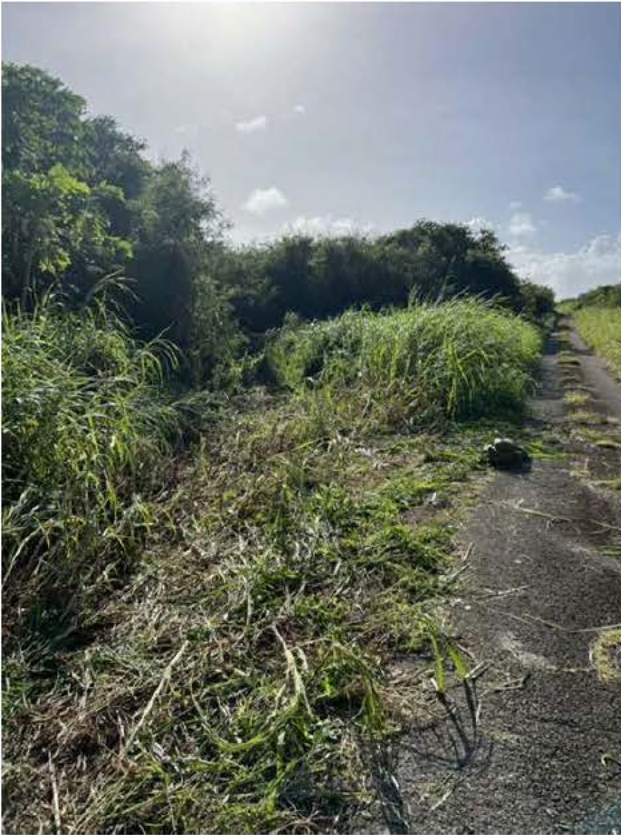
The MV departed the road to the left and entered the thick vegetation (Tabs R-77, R-97, and V-4.9). The MV completed a counterclockwise right leading rollover, coming to rest back on its tires against trees more than 30 feet from the road (Tabs R-77, R-97, O-4, and V-5.4.). Neither MA1 nor MA2 were wearing seatbelts or other personal protective equipment (Tabs V-3.6 and V-8.4 to V-8.5). MA1 was ejected from the MV and sustained serious injuries, resulting in permanent paralysis below the waist (Tabs V-4.9 and Tab X-4). MA2 was ejected from the MV (Tabs V-3.6 and V-8.6). During the rollover and after ejection, the MV struck MA2 causing life-threatening injuries to include a pelvic fracture and internal abdominal injuries, which has resulted in numerous corrective surgeries and an above-the-knee amputation (Tabs V-8.7 and Tab X-5 to X-6).

**Figure 4: Vegetation flattened by MV after departing road (view - direction of travel) (Tab S-150)**

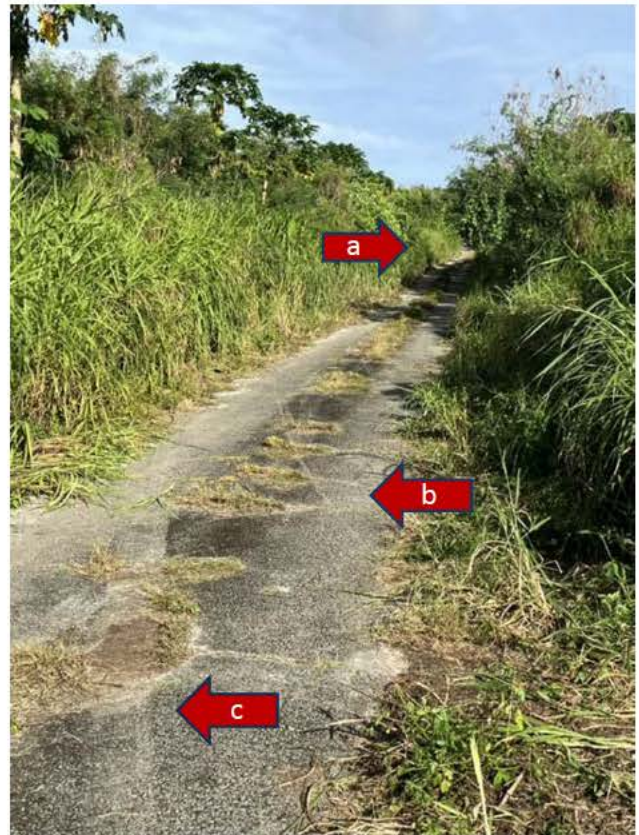
**Figure 5: (a) Road narrowed by vegetation overgrowth, (b) and (c) MV tire marks departing road (view - opposite direction of travel) (Tab S-158)**

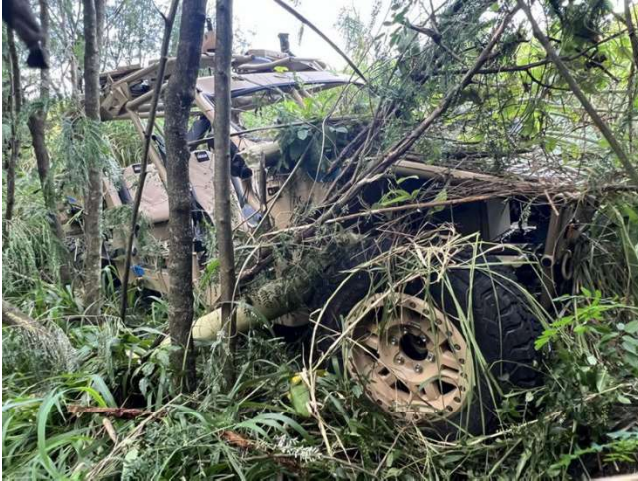
**Figure 6: Passenger side of MV at mishap site (Tab S-172)**

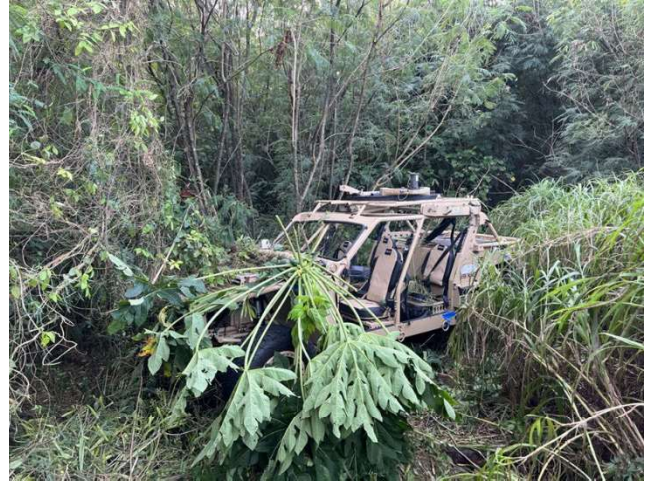
**Figure 7: Driver side of MV at mishap site (Tab S-189)**

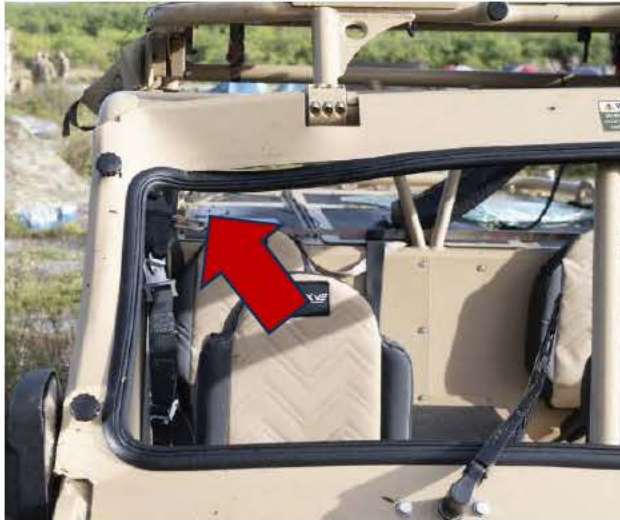
The MV was inspected by the GAIB, which noted that damage was almost entirely on the passenger (right) side (Tabs J-3 to J-6).

**Figure 12: Missing passenger side windshield and bent frame (Tab S-73)**

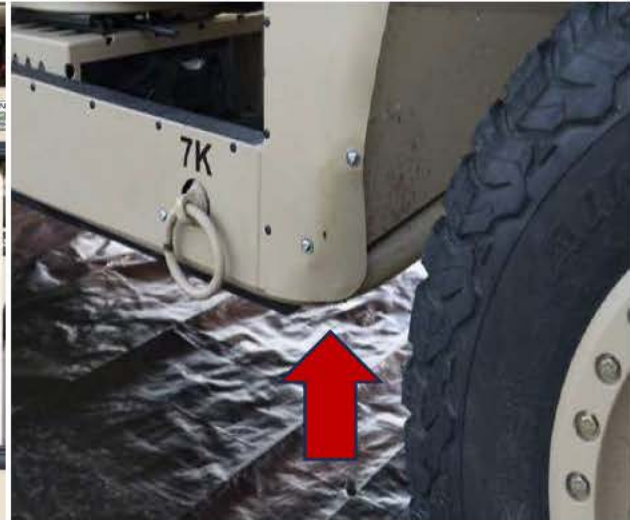
**Figure 13: Passenger side wheel well damage (Tab S-69)**

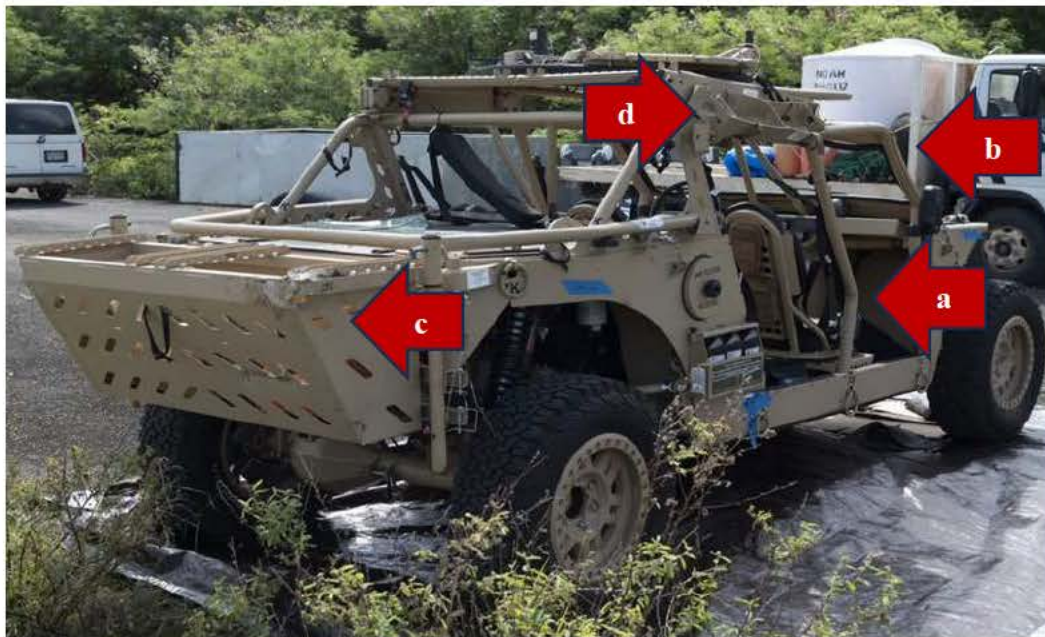
**Figure 14: (a) Bent roll cage by passenger seat, (b) Bent windshield frame, (c) Damage to cargo bin on rear passenger side, (d) Crushed bins on passenger side roof (Tab S-142)**

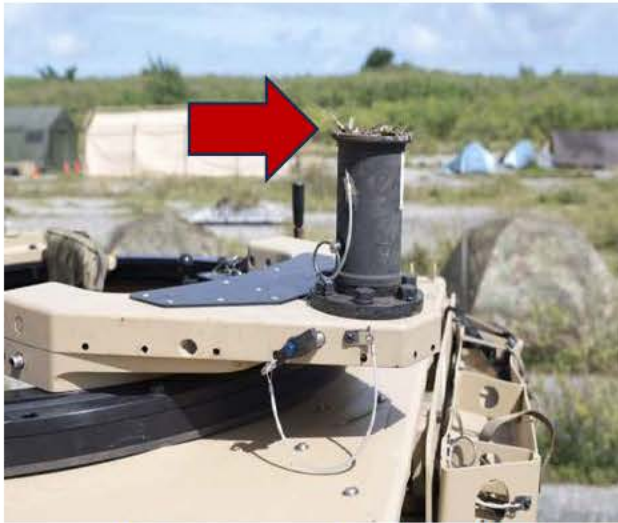
**Figure 15: Turret mount packed with dirt and vegetation on roof of the driver side (Tab S-136)**

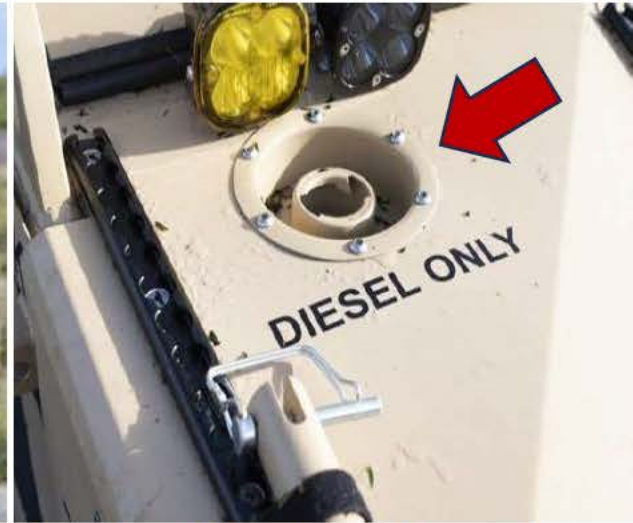
**Figure 16: Missing diesel fuel cap on the passenger side hood (Tab S-88)**

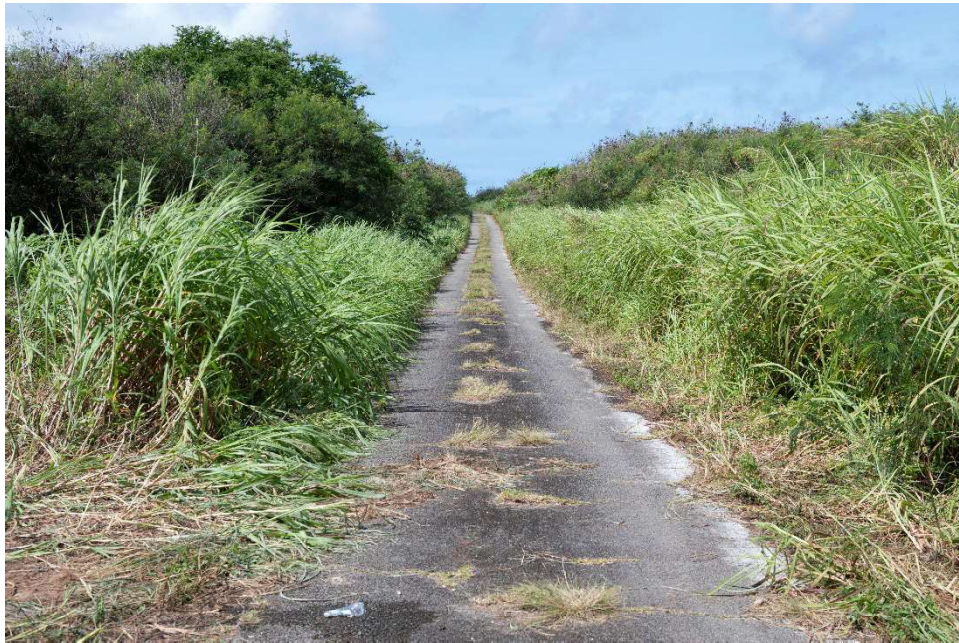
Most roads on Tinian were designed, developed, and constructed in 1944, with many of the existing roads now in poor condition (Tab BB-84). The unnamed roads in the North Field area are typically unpaved, moderately to severely overgrown with vegetation, and experience low traffic volumes (Tab BB-86). These roads have not been improved or resurfaced since their original construction during World War II (Tab V-5.6).

**Figure 17 - Unnamed Road Where Mishap Occurred (Tab S-13)**
