**UNITED STATES AIR FORCE**  
**GROUND ACCIDENT INVESTIGATION**  
**BOARD REPORT**

**SEARCH AND RESCUE TACTICAL VEHICLE –  
SIDE BY VEHICLE  
S/N SRTVSXVD21AFM060**

**TYPE OF ACCIDENT:  
Tactical Vehicle Serious Injury**

**DATE OF ACCIDENT: 17 February 2023**  
**BOARD PRESIDENT: Colonel Brendan M. Noone**  
**Conducted IAW Air Force Instruction 51-307**

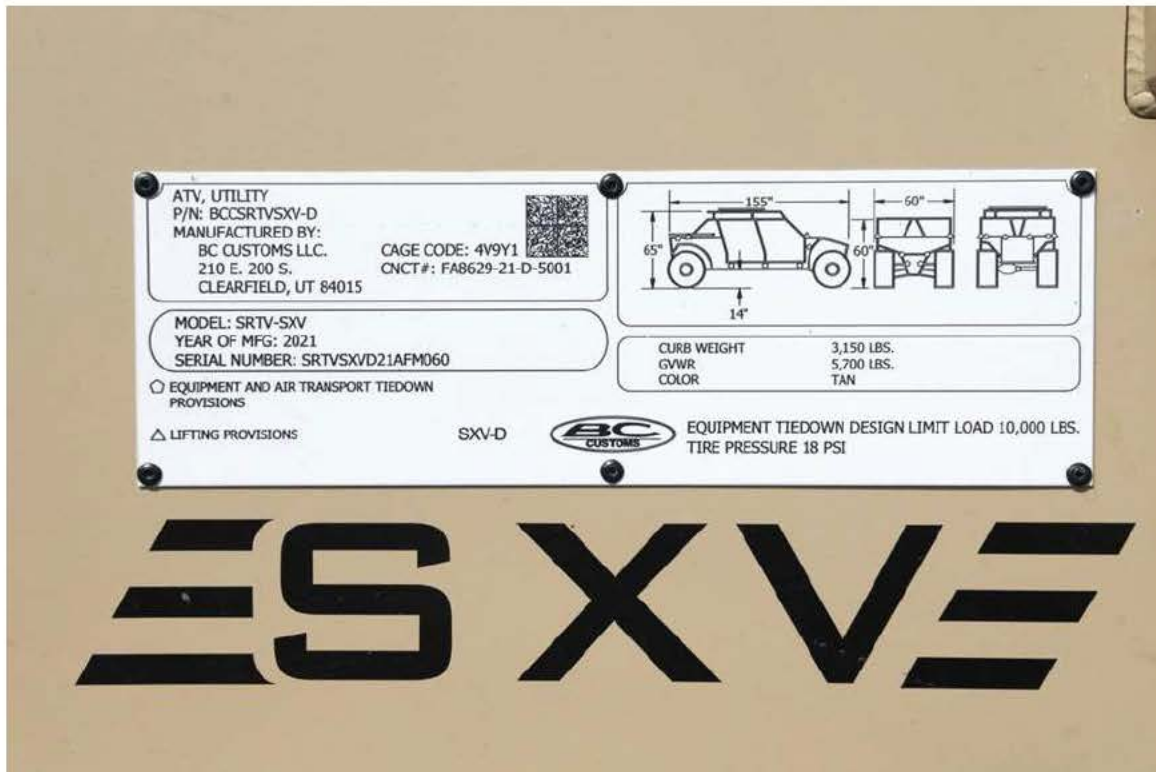
**Figure 9: MV data plate identifying OEM and S/N (Tab S-91)**

The SRTV-SXV, S/N SRTVSXVD21AFM060, had recently been delivered to 31 RQS, with the acceptance limited technical inspection (LTI) dated 17 January 2023 (Tab U-3). No maintenance documentation or evidence of inspections were present on the MV at the time the GAIB took custody (Tabs A-7 to A-11 and V-11.3-11.4).

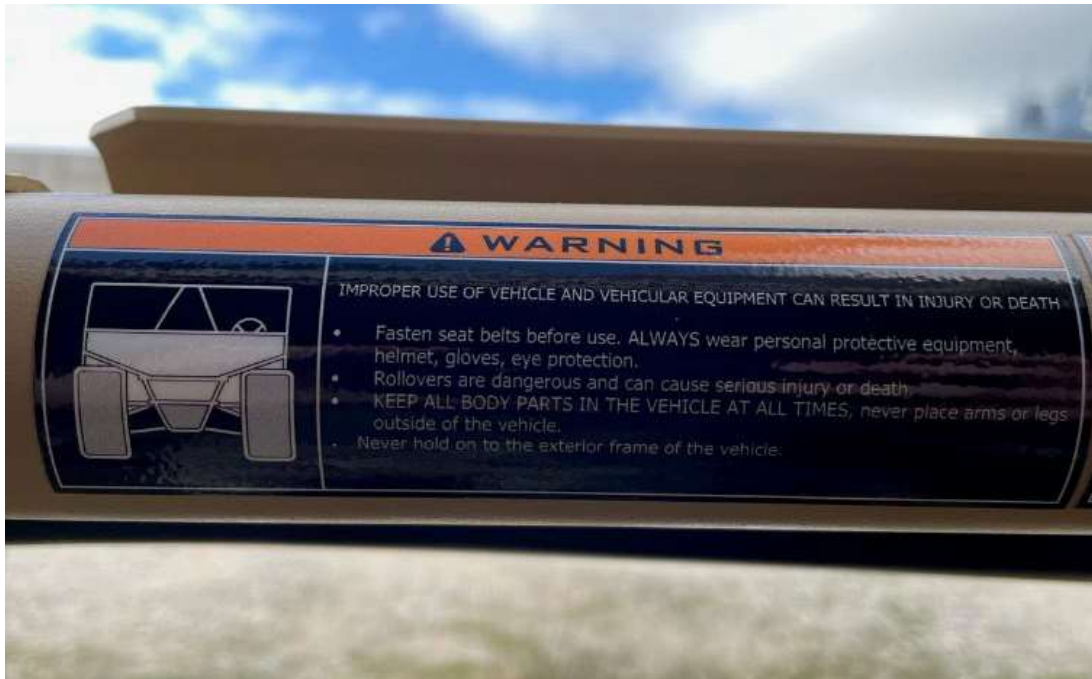
**Figure 10: Warning label above steering wheel: “Fasten seatbelts before use. ALWAYS wear personal protective equipment, helmet, gloves, eye protection” (Tab S-202)**

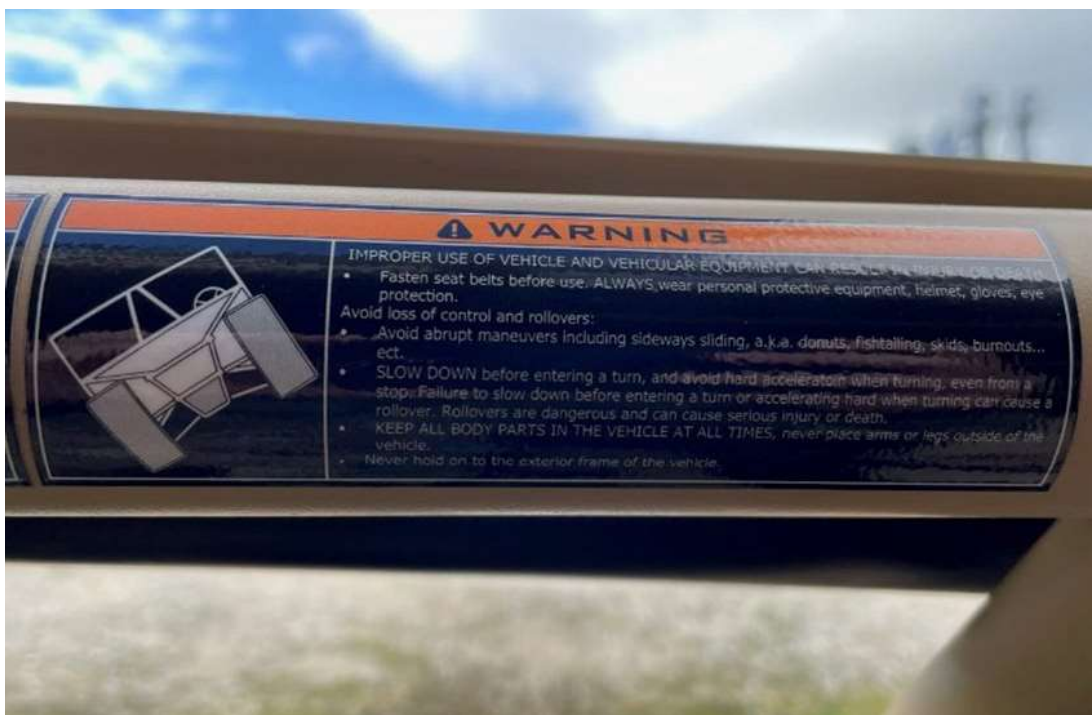
**Figure 11: Warning label above steering wheel: “SLOW DOWN before entering a turn and avoid hard acceleration when turning even from a stop. Rollovers are dangerous and can cause serious injury or death” (Tab S-203)**
